Name Of Dam: MIDDLETON DAM  
Location: LEE COUNTY, VIRGINIA  
Inventory Number: VA. NO. 10501

# PHASE I INSPECTION REPORT

## NATIONAL DAM SAFETY PROGRAM

Name of Dam: Middleton Dam      Va. No. 10501  
State: Virginia  
County: Lee  
USGS Quad Sheet: Pennington Gap  
Coordinates: Lat 36° 45.5'    Long 83° 06.9'  
Stream: Bowman Hollow  
Date of Inspection: May 23, 1979

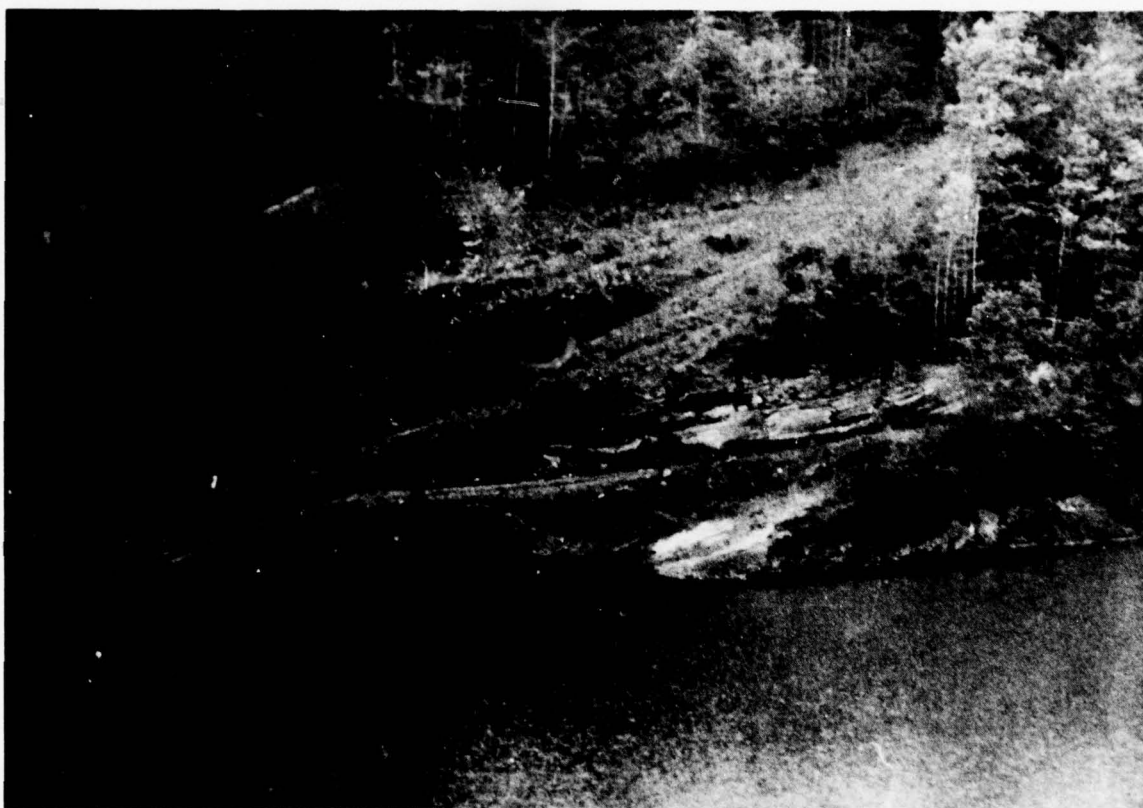
VIEW OF CUT AT RIGHT ABUTMENT

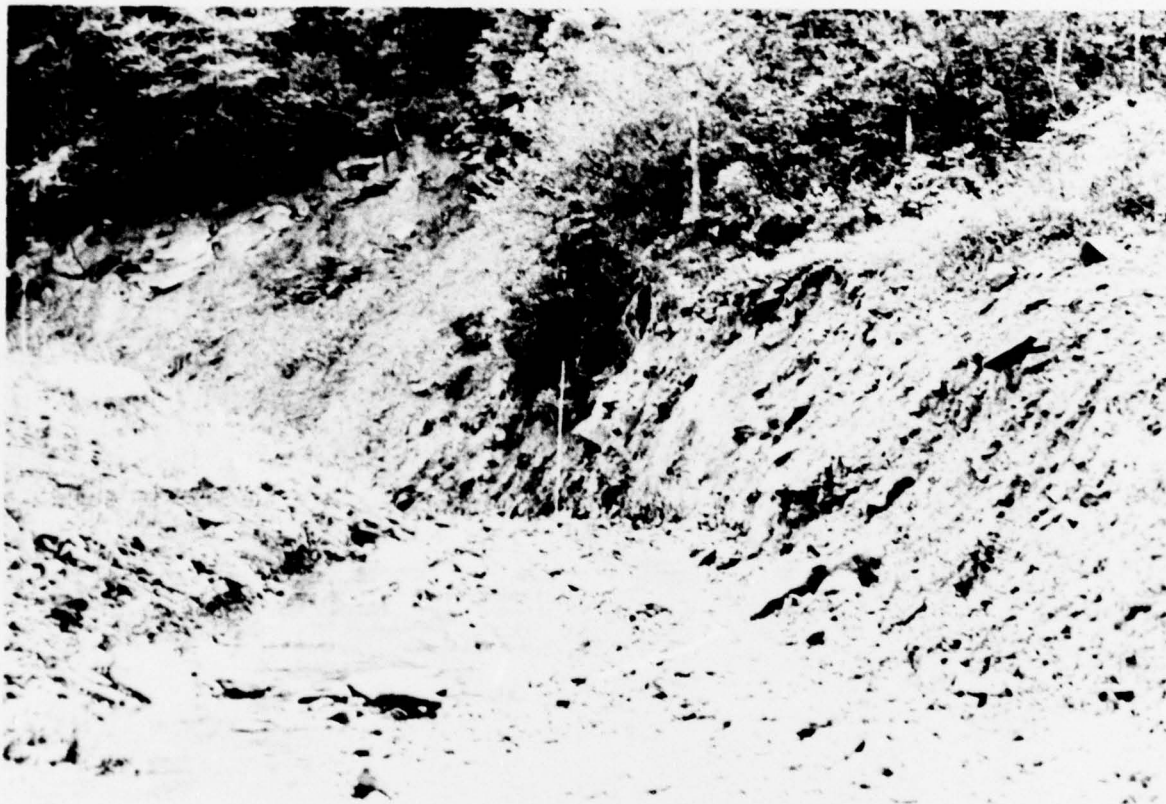
The emergency spillway is located at the right abutment. The left side of the emergency spillway is at a slope of 1.5:1 and in fill. The right side of the spillway is at a 1:1 slope and is in cut. Previous erosion reported by the owner had been repaired.

PHOTOGRAPH EMERGENCY SPILLWAY

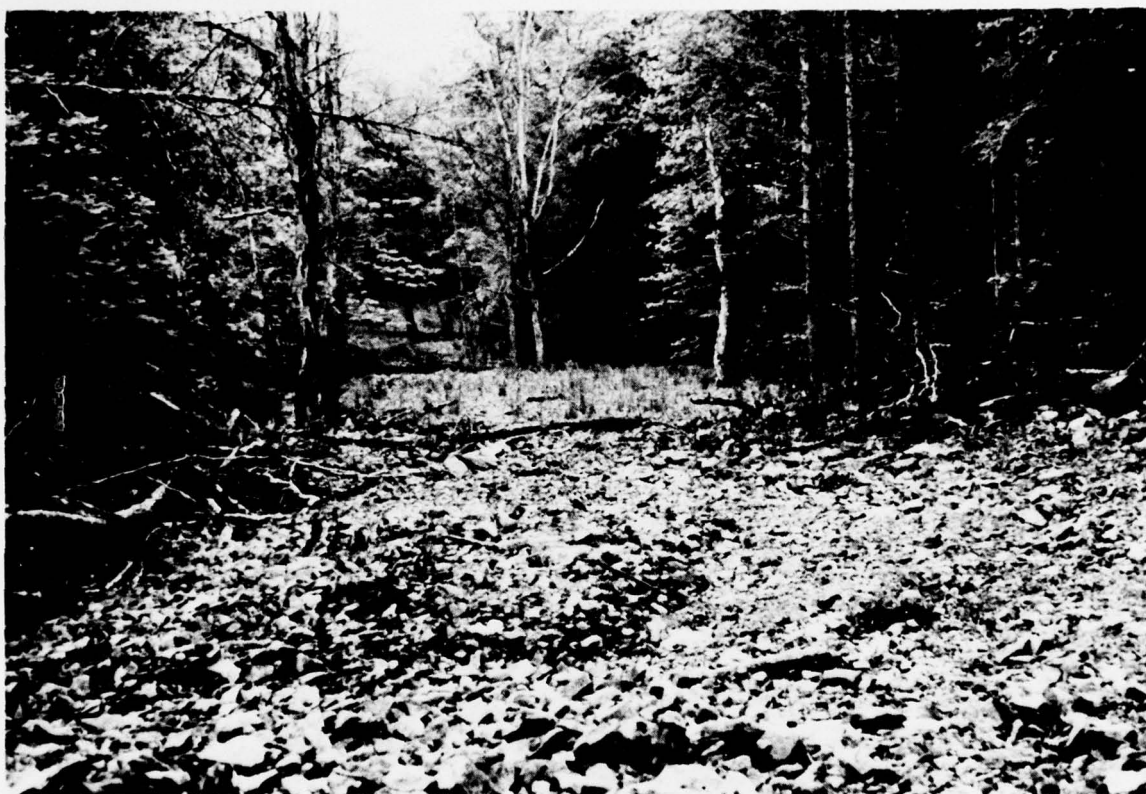
VIEW LOOKING DOWNSTREAM FROM EARTHEN BERM

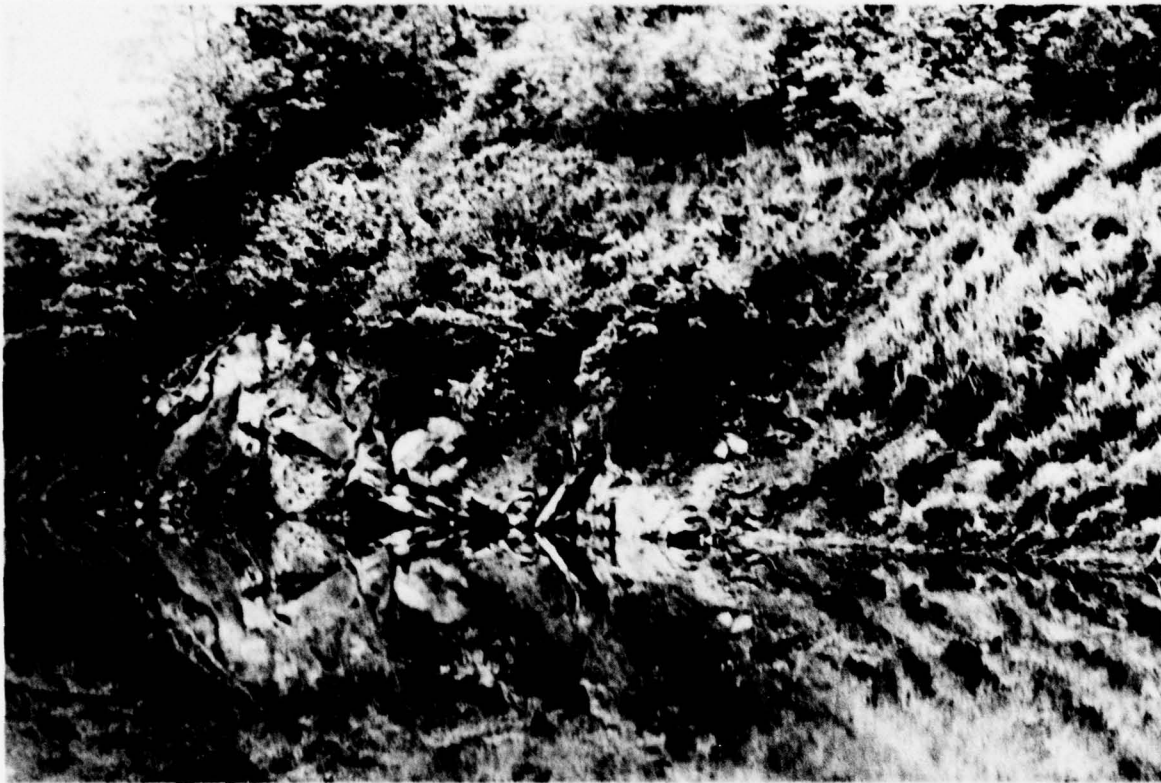
VERTICAL SLOPE AT LEFT ABUTMENT
